Project Name: WRHM Radio Tower, Alternate Access Road

Project Number: FCC # not specified; FAA ASN # 2006-ASO-699-OE

Objective: To conduct a field survey of a newly proposed access road to a previously surveyed radio tower site. Background work is limited to review of SCIAA archaeological site files; historical and architectural background is being conducted by Mr. Michael Scoggins.

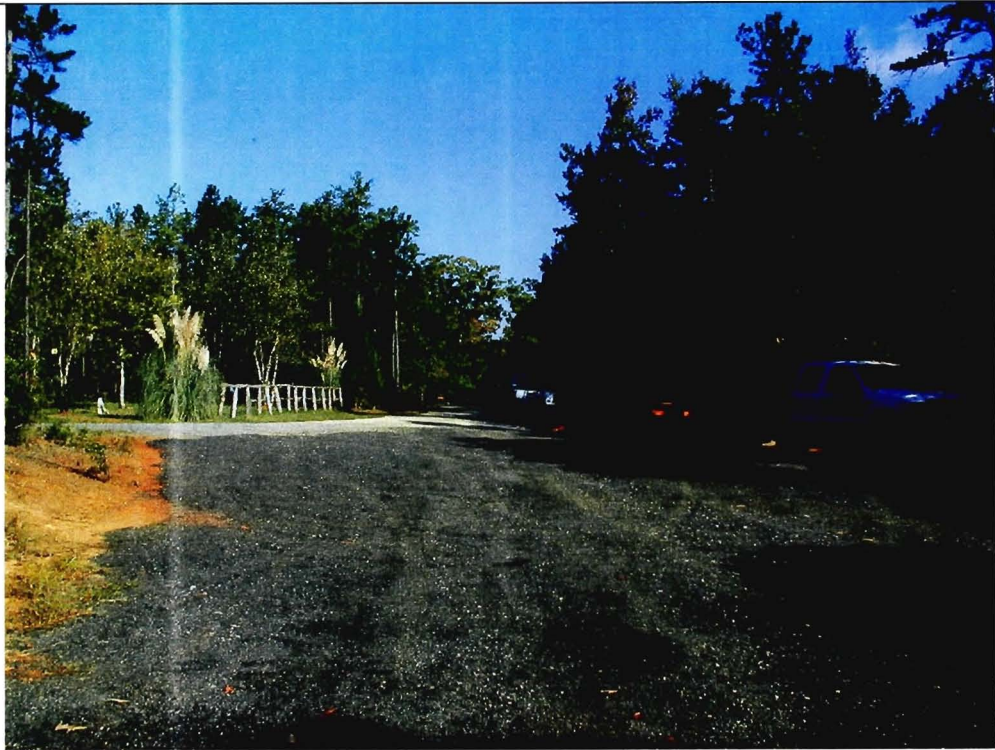
Figure 2. Existing gravel road, called Dirt Road, looking south from beginning of new location .

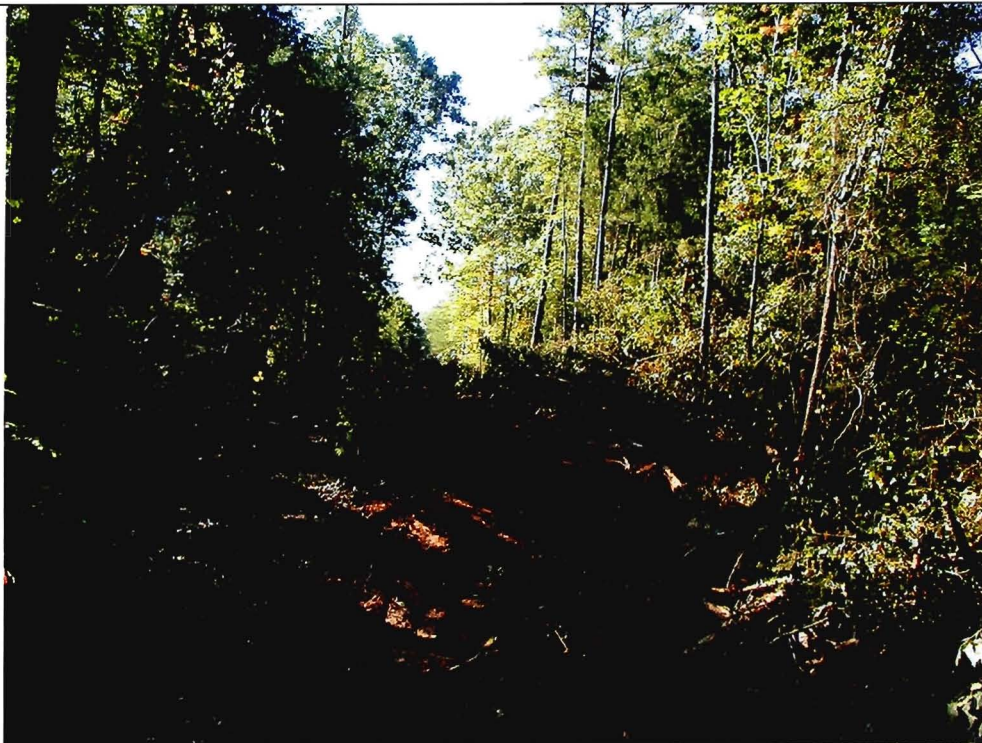
Figure 3. Proposed new access road with red clay exposed at the surface.

Results: None of the shovel tests in the access road identified any cultural remains. Occasional quartz cobbles were identified, but all were unaltered and exhibited no evidence of burning or use. Soils throughout are heavily eroded, steeply sloping, and gullied. The potential for the identification of cultural remains is very low.
